WAQUOIT BAY STREAM RESTORATION MASTER PLAN

Falmouth and Mashpee, Massachusetts

Waquoit Bay National Estuarine Research Reserve

December 16, 2010

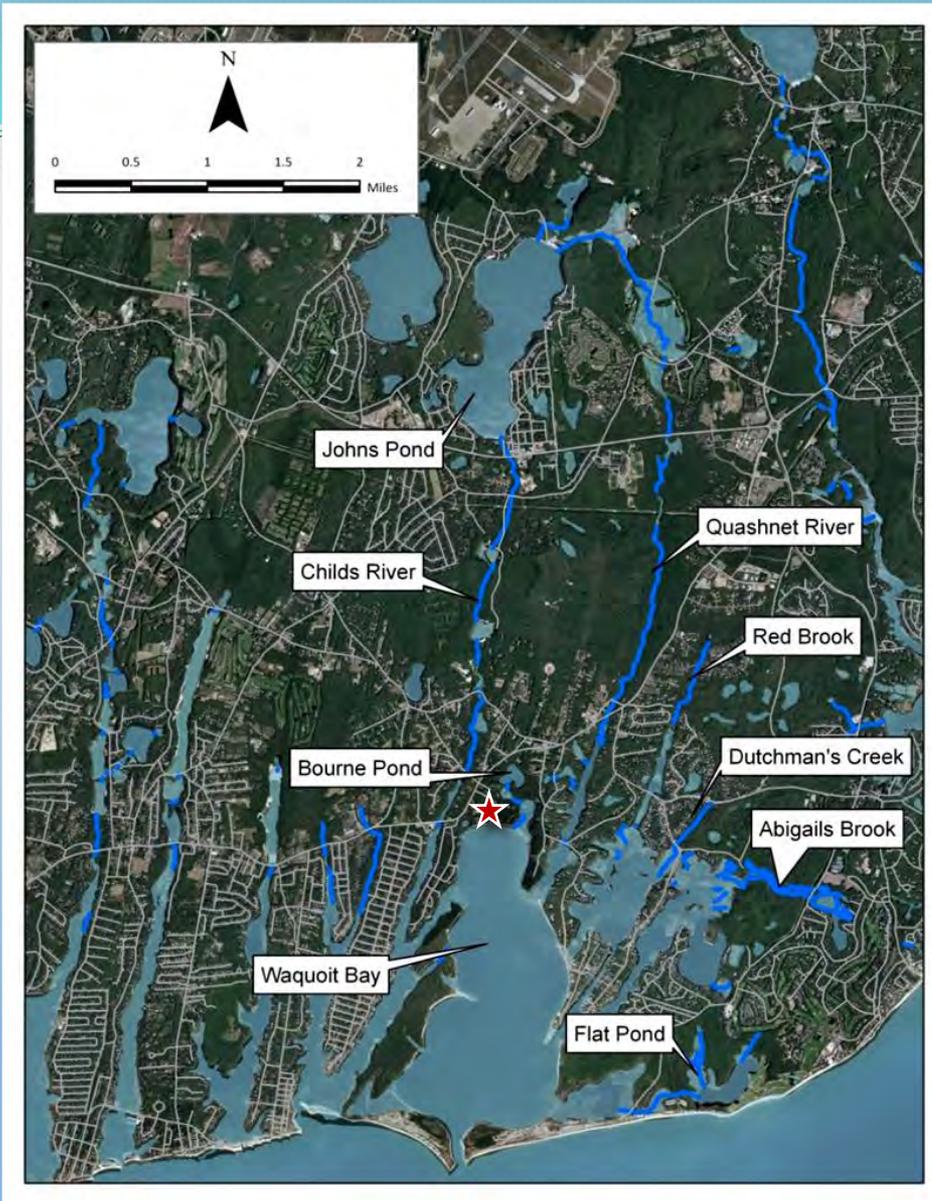
Stream Systems:

- Childs River
- Bourne Pond
- Quashnet River
- Red Brook
- Dutchman's Creek
- Abigails Brook
- Flat Pond

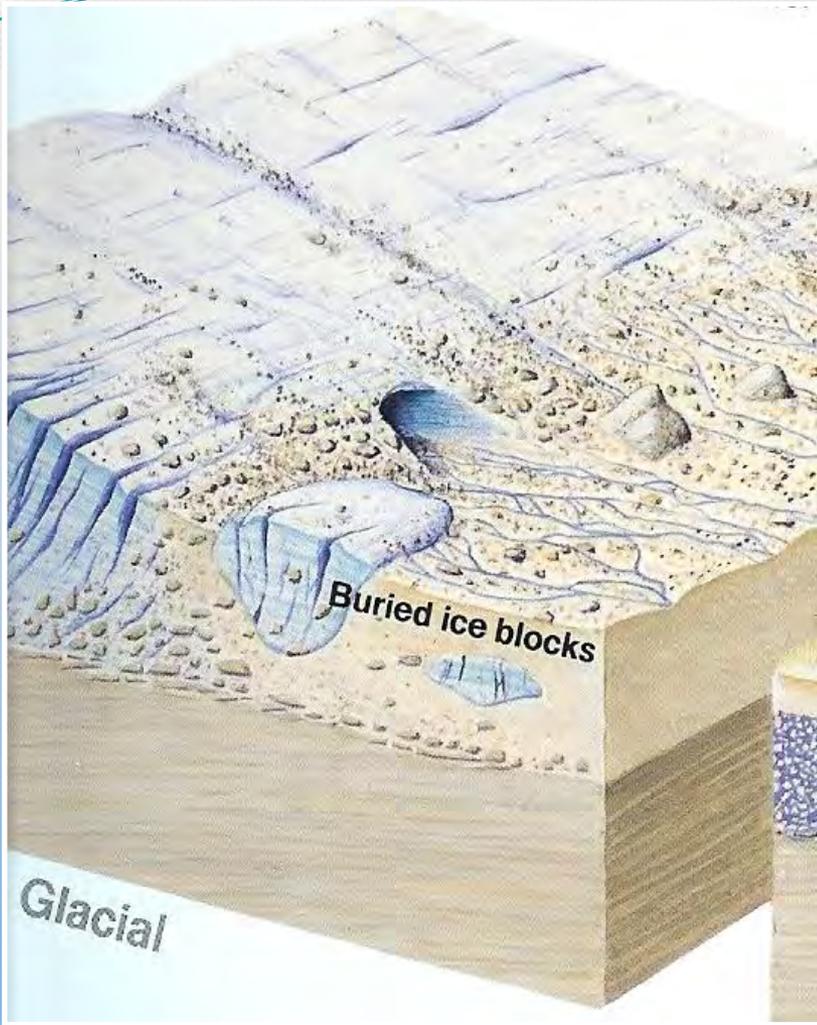
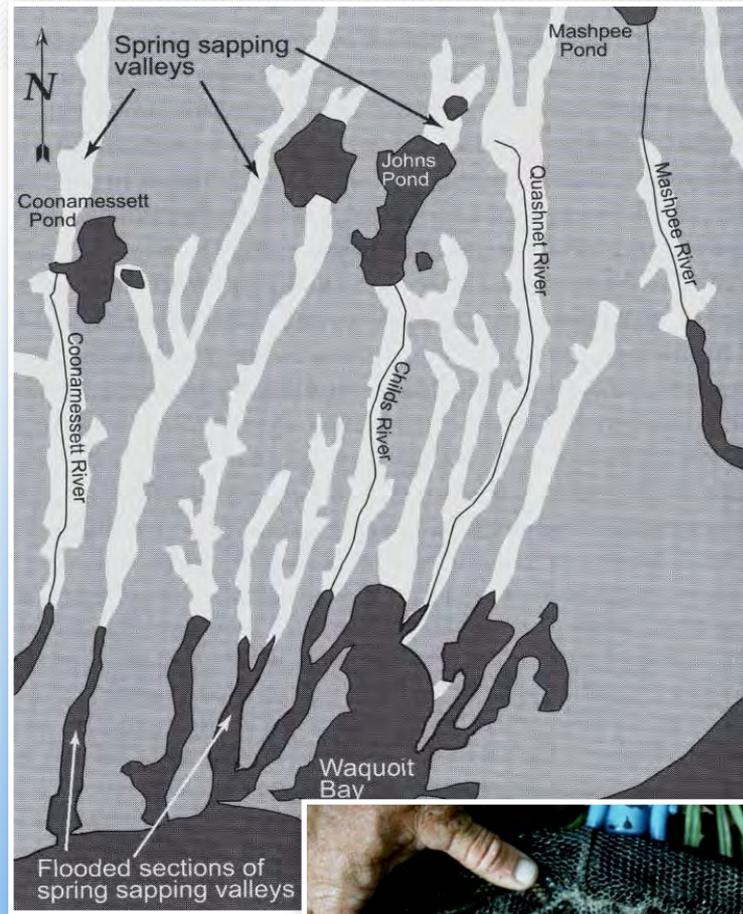
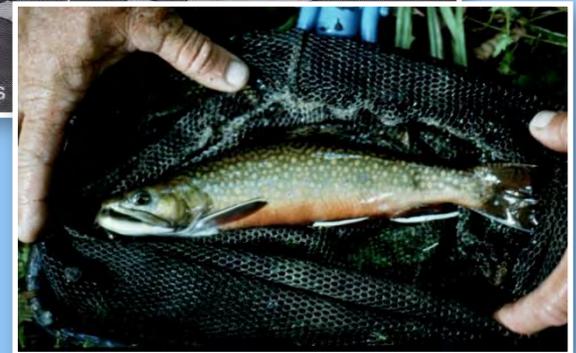
Spring Sapping Valleys

(from: Schwarzman 2002 and Finch-Cape Cod)

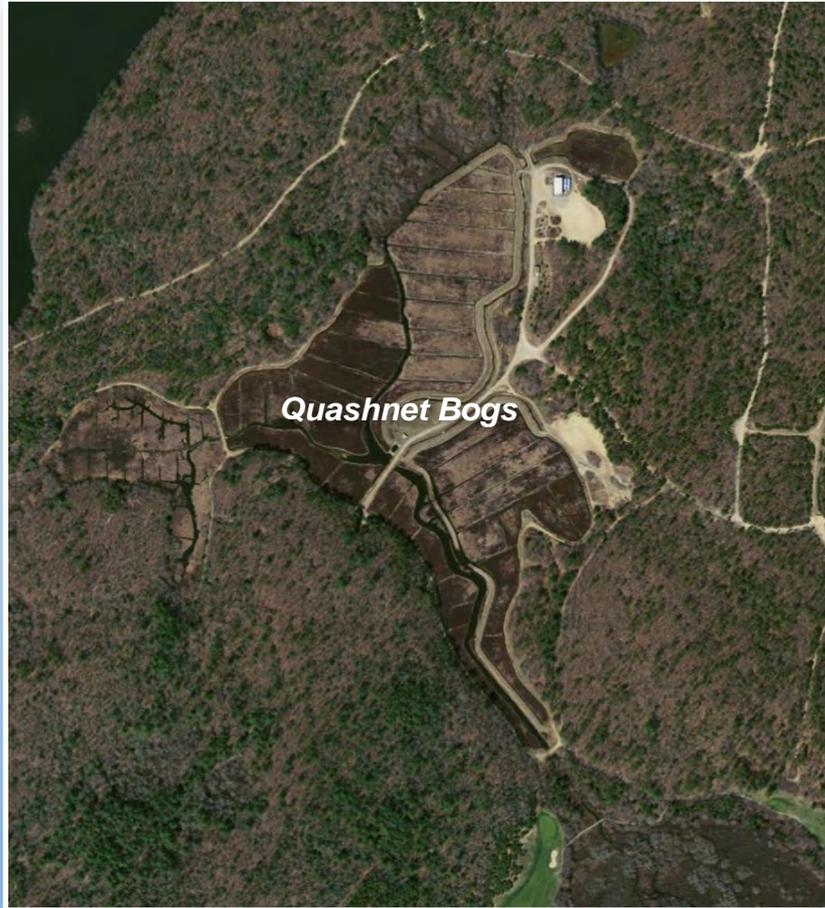
Cranberry Production

Watershed Impacts

- Channel straightening
- Disconnected floodplains
- Loss of woody material/riparian forest
- Elevated water temperatures
- Impounded conditions
- Lack of flow regime diversity
- Obstructions/loss of connectivity

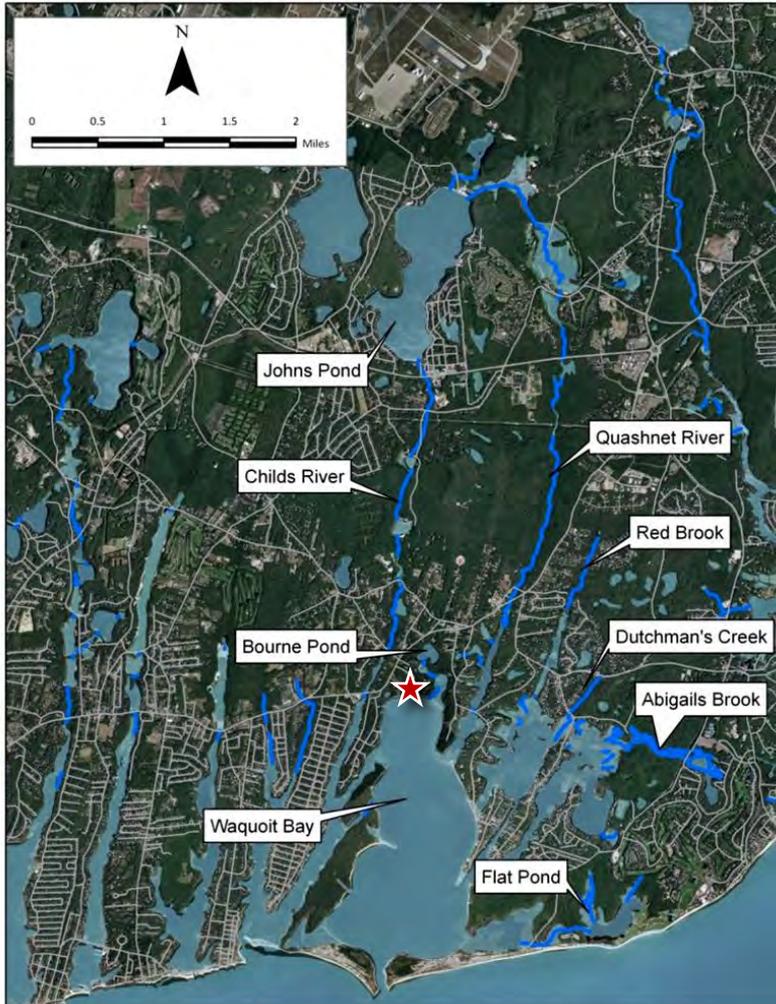
Inventory of Potential Sites

Childs River	12
Bourne Pond	2
Quashnet River	16
Red Brook	5
Dutchman's Creek	2
Abigails Brook	4
Flat Pond	1

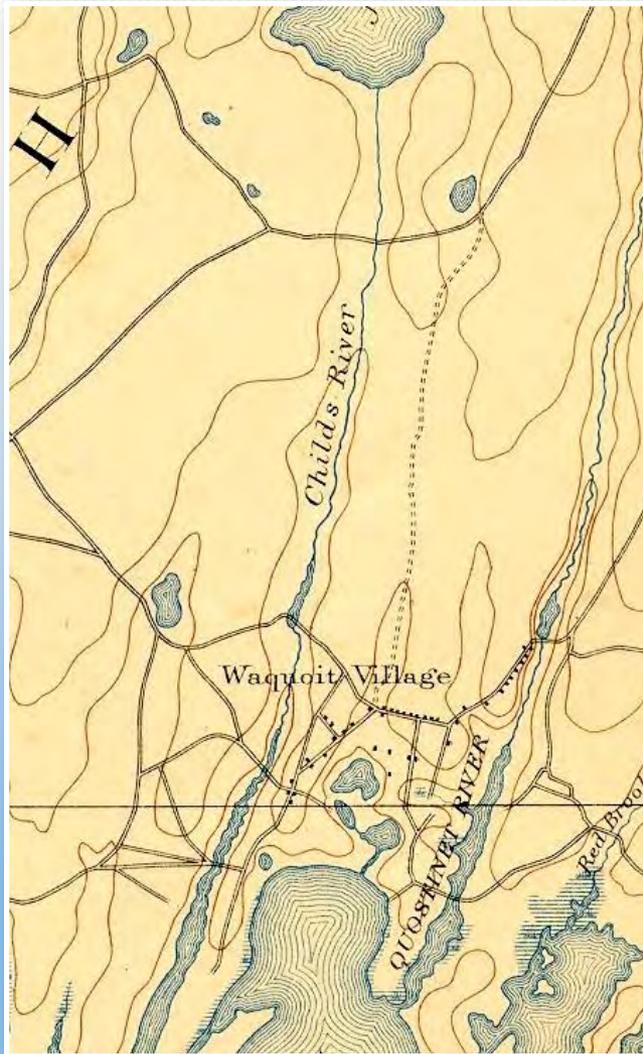
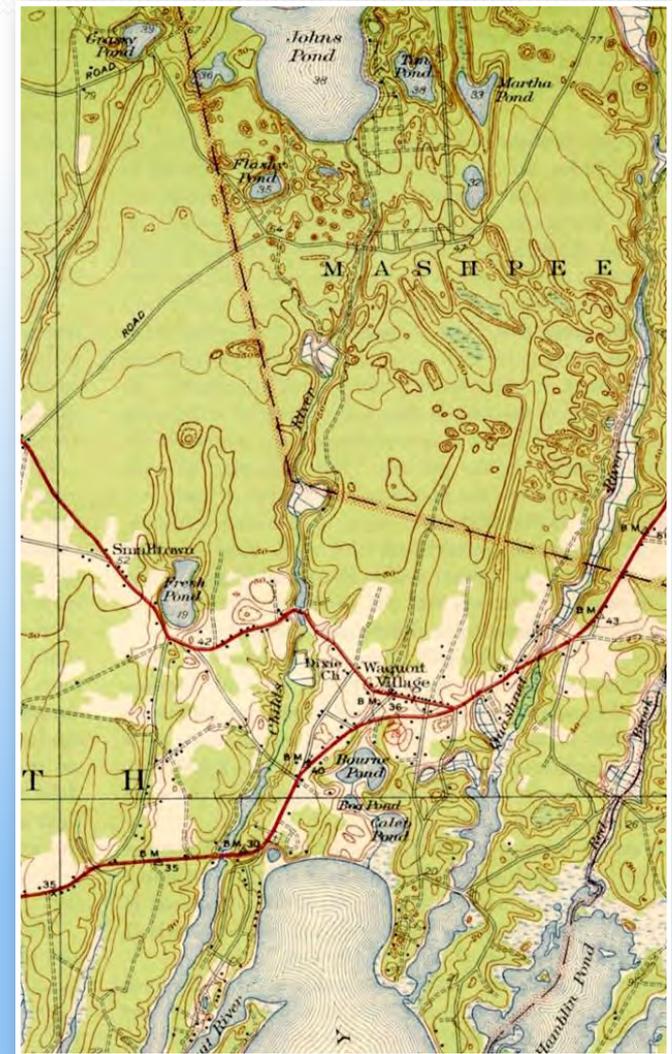
Childs River – Carriage Shop Dam

Current issues:

- Existing fishway in poor condition
- Falmouth Rod & Gun Club ponds very shallow with extensive aquatic vegetation growth and sediment accumulation
- Impoundment acts to increase water temperatures in brook trout stream with most trout occurring below dam

Riverways study (Milone & MacBroom 2008) recommended full dam removal at cost of up to \$575,000

Other options include:

- Replacement of existing fishway with new “technical” fishway (such as Denil, but upstream herring passage not a major objective for river)
- Partial dam removal with conversion of existing fishway channel to nature-like fishway, lower pond level, create new stream channel, wetland restoration (preferred)

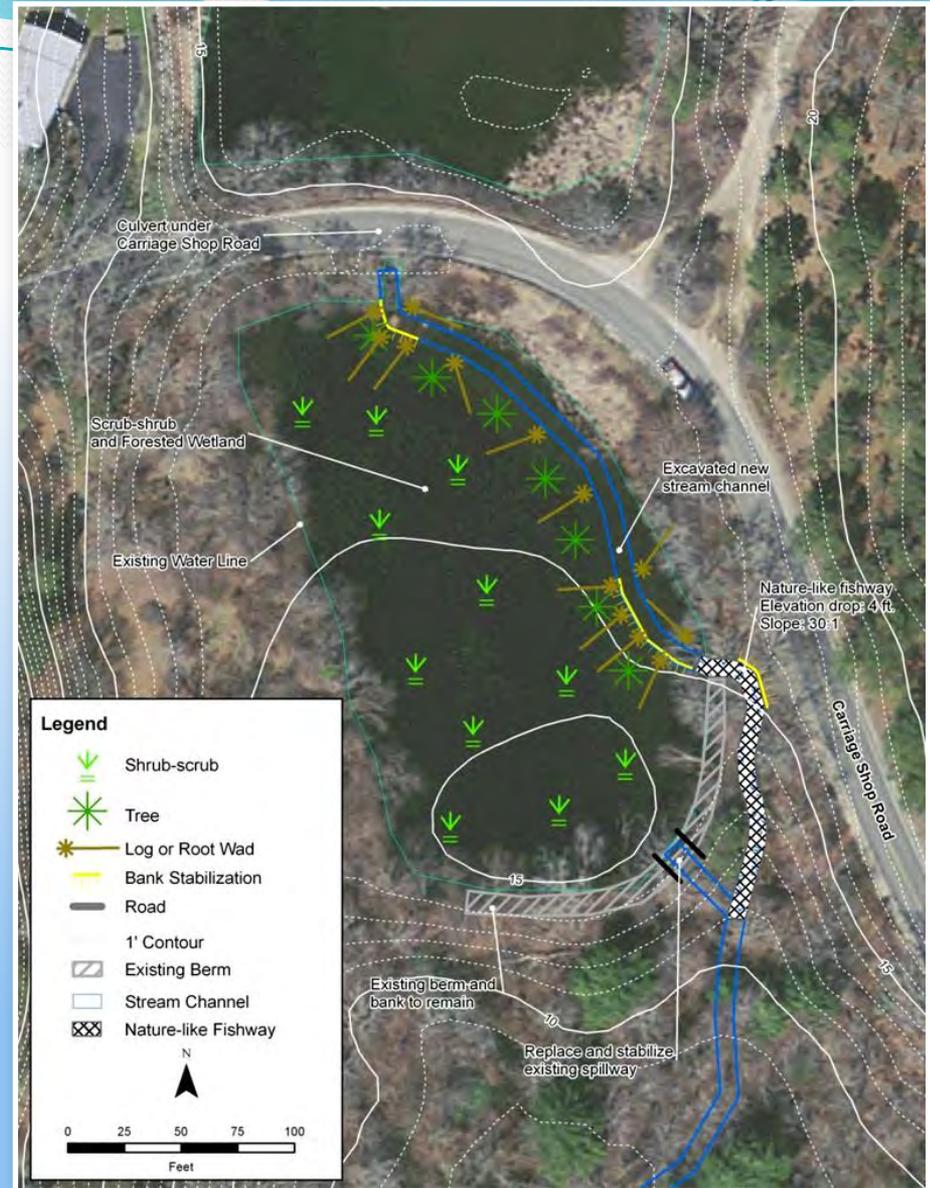
- **Creates stream habitat in new stream channel in former pond, and in nature-like fishway**
- **Provides for fish passage at the site for river herring, trout, and other species**
- **Allows for restoration of scrub-shrub and forested wetland in former pond**
- **Lower cost than full dam removal**

Nature-like fishway:

- Estimated head – 4 feet
- Slope – 20:1 to 30:1 depending on topography and head
- Length – 80 to 120 feet, drop per pool approx. 6 inches
- Width – 15 to 20 feet
- Rock/boulder weirs with interspersed instream boulders and cobble/gravel substrate in pools
- Design flow – 15 to 20 cfs -based on average monthly flows on the Quashnet River – max. annual flows on Quashnet typically 30 to 40 cfs. (Design flows to be prorating by drainage area)
- Current outlet from pond to be replaced and stabilized

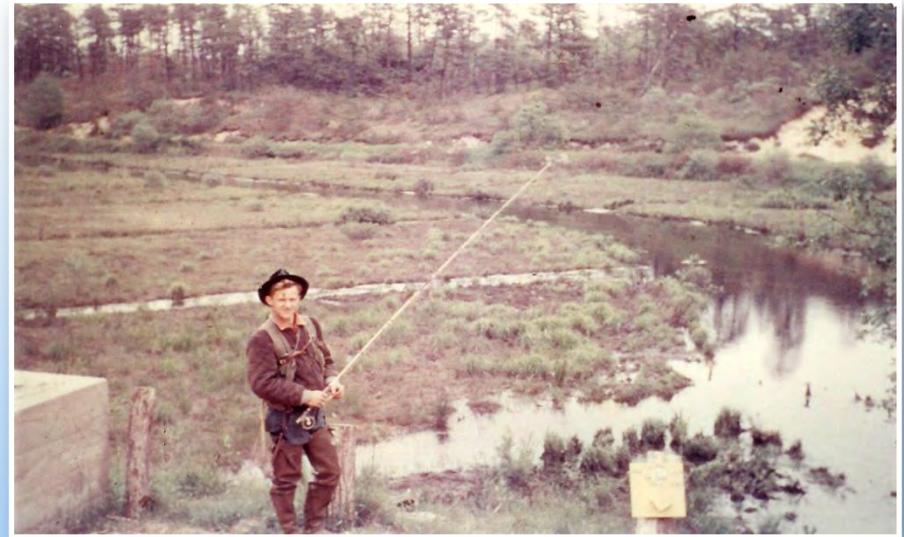
Lower Quashnet River bogs abandoned and purchased by Division of Fisheries and Game – 1956 (picture of David Leonowicz near Martin Rd., 1953)

- Several water control structures remain from past cranberry operations
- Open for fish passage
- Potential for structural failures
- Impediments to river connectivity and wildlife passage in river corridor
- Potential for flow restriction/impounding of flows
- Channel location/spring seeps

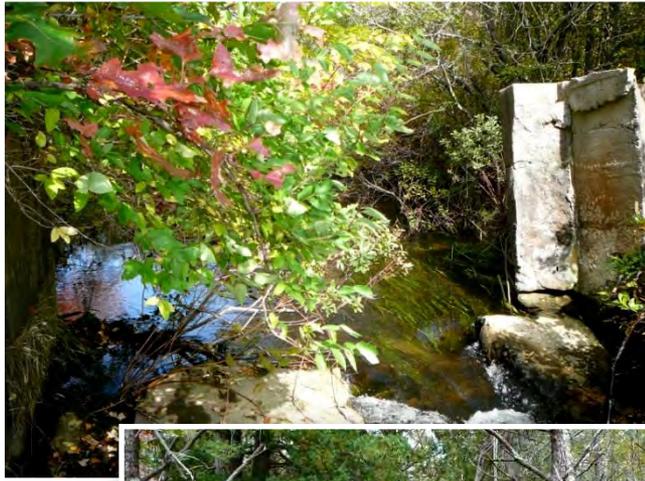
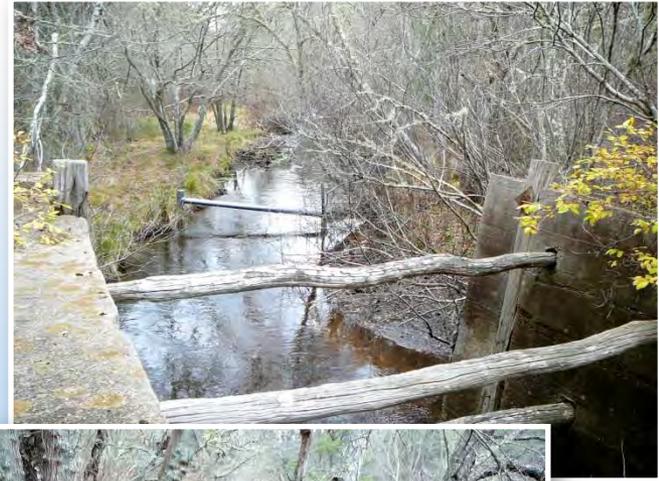
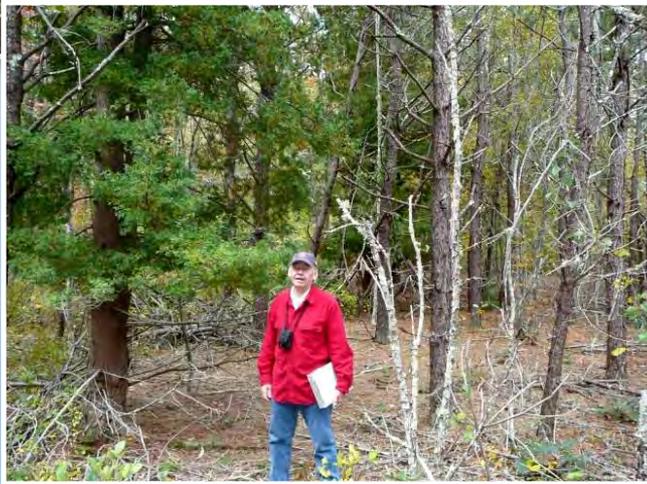
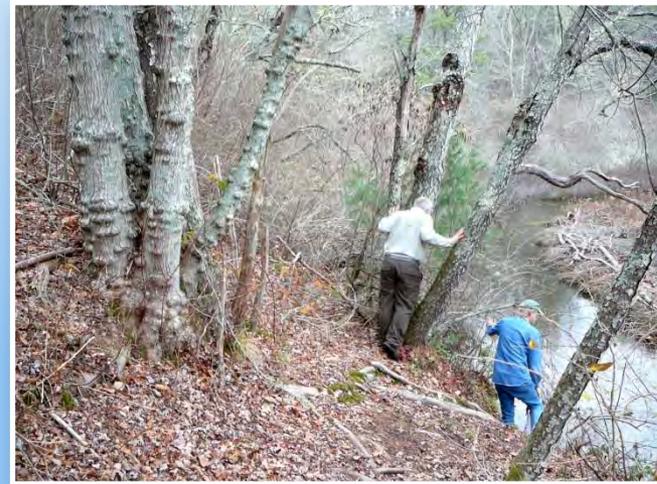
Restoration Opportunities

Middle Quashnet River

Potential Restoration Measures:

- Regular inspection & maintenance program to ensure structures are open
- Removal of failing concrete structures, leave associated berms in place
- Removal of concrete structures and berms, river corridor restoration
- Those to remain subject to regular inspections
- In-stream habitat enhancement
- Restore natural stream process, function and values (self-sustaining)

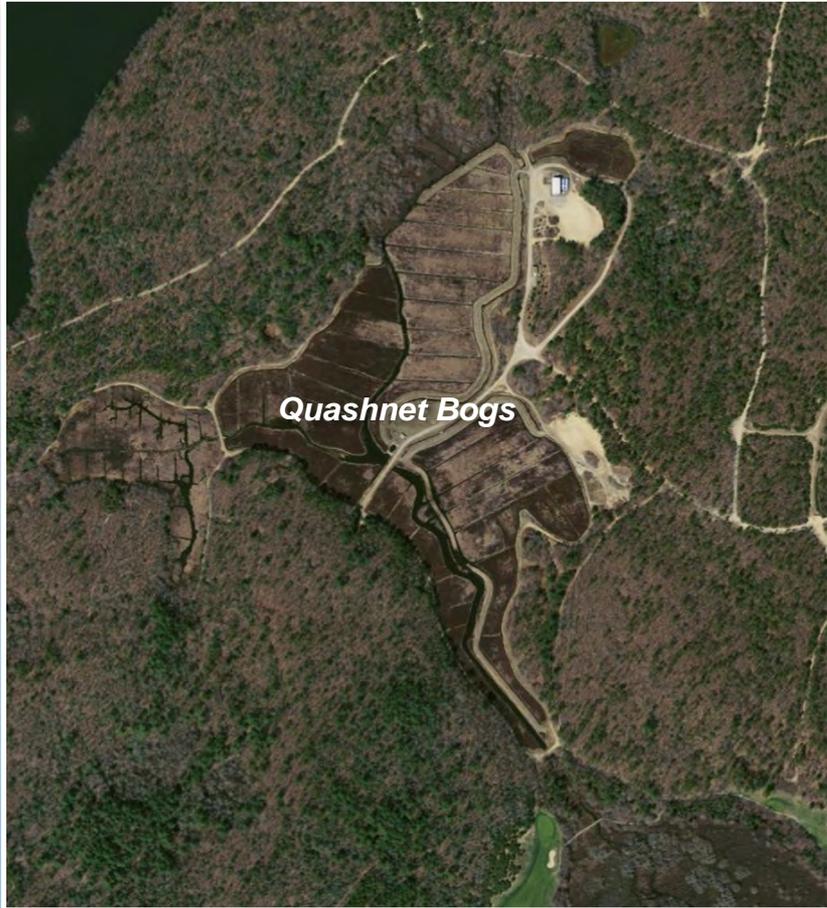
Impairments:

- Cutting of white cedars, shingle mill dam, cranberry cultivation (mid-1900's)
- Ethylene Di-bromide (EDB) Treatment
- Channel straightening
- Disconnected floodplains
- Loss of woody material/riparian forest
- Elevated water temperatures
- Loss of wetland habitat
- Lack of flow regime diversity
- Obstructions/loss of connectivity

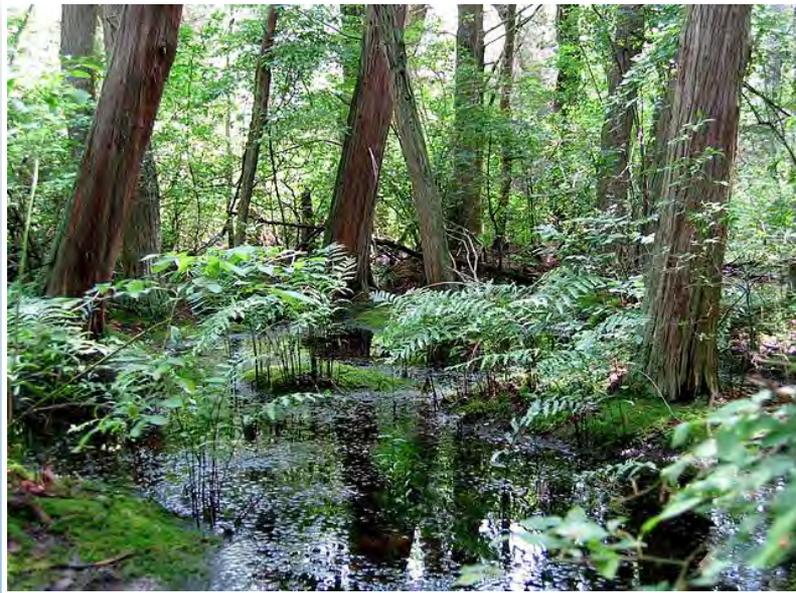
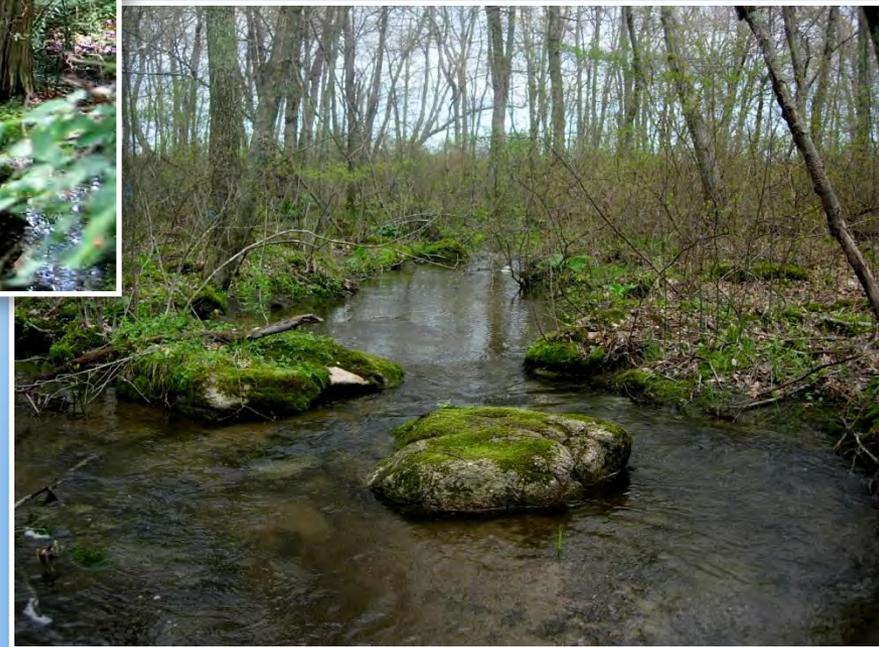
Reference Wetlands

Atlantic White Cedar Swamp

Red Maple Swamp

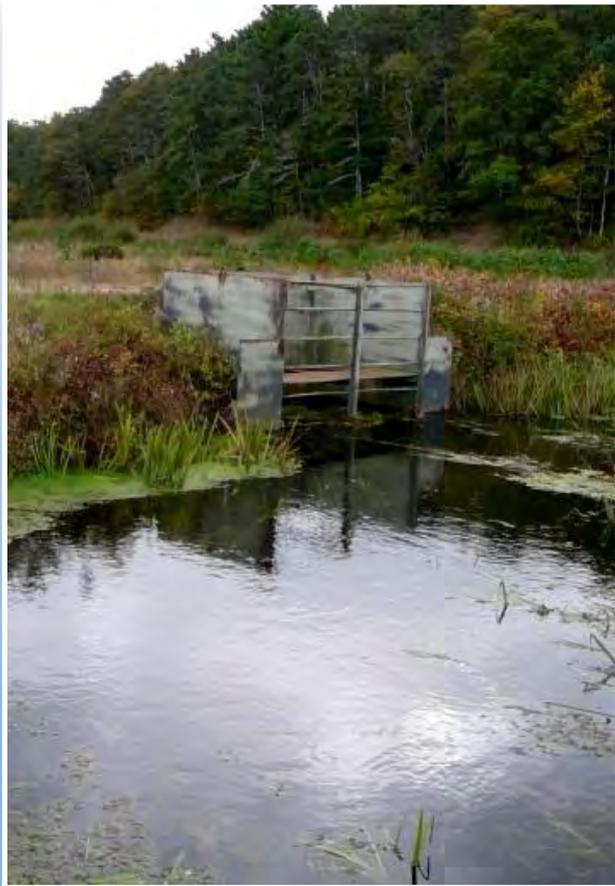
Restoration components

- Restore natural stream alignment, width, depth, slope, and substrate (sand/gravel with upwelling cool water)
- Stream flow regime/diversity
- Bank stability
- Establish forested wetland/riparian forest/shading
- Logs and root wads
- Restore wetland hydrology (elevate groundwater-grade controls/plug ditches)
- Modify bog surface
- Atlantic white cedar/red maple plantings
- Planting/Deer exclusion fencing

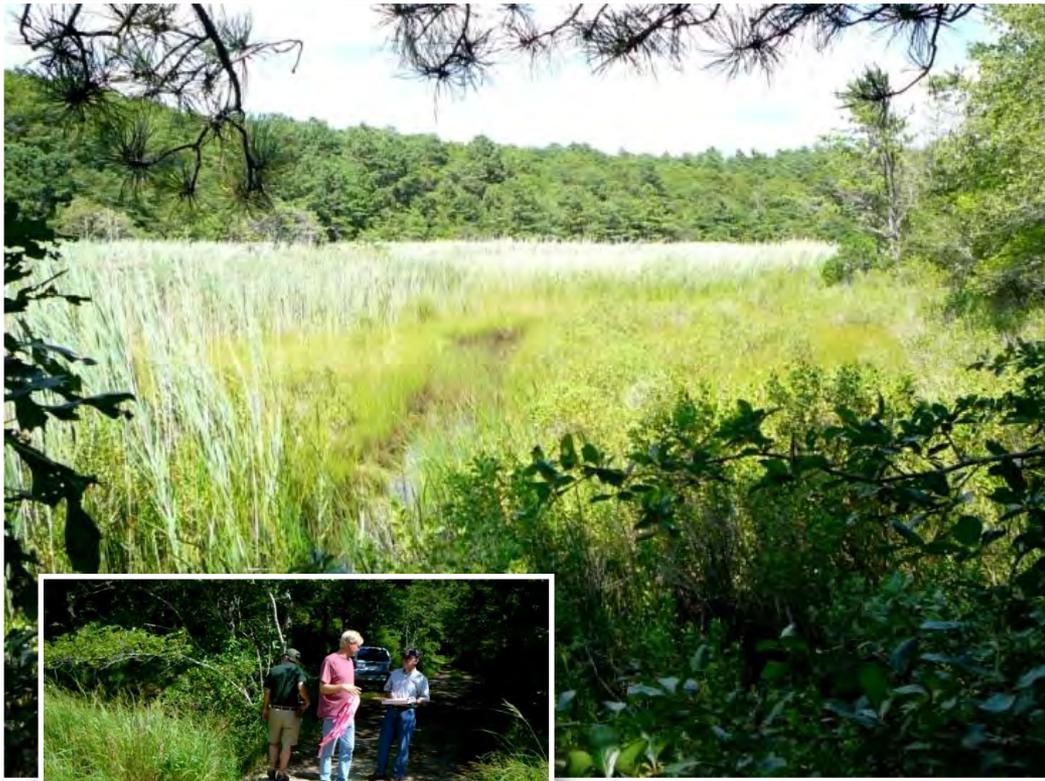
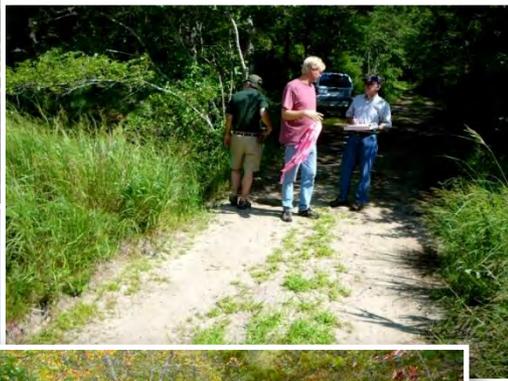
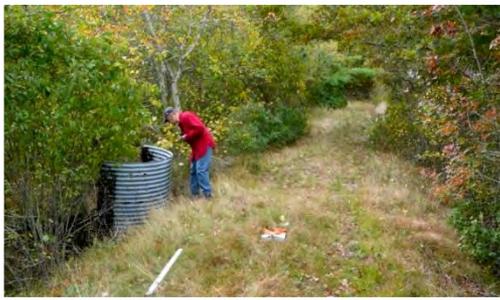
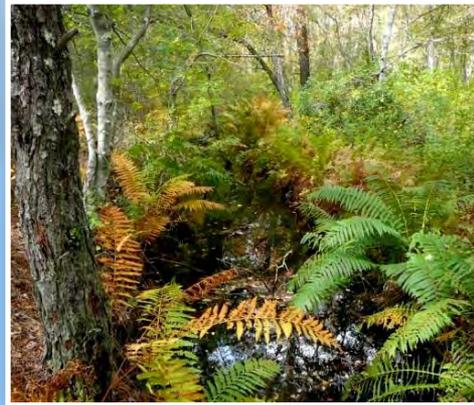
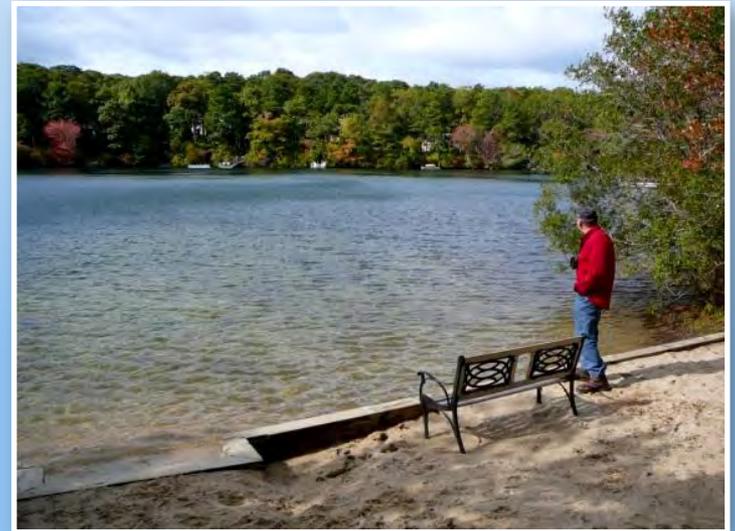
Impairments:

- Tidal Restriction
- Obstructions/loss of connectivity
- Invasive species
- Channel straightening
- Disconnected floodplains
- Fish run potential (Fells Pond)
